Water Sources Assessment Report. Bagh Town.

Date: 3rd July, 2006

Report prepared by WHO team, Bagh Hub.

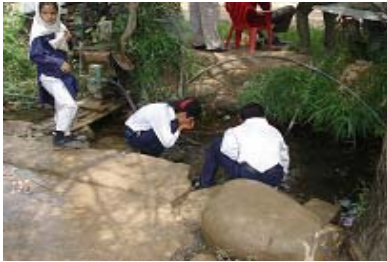
N33° 58.544' E73° 46.931' Alt. 3536'
Bypass Road near Spring field Sch.

8	Spring 8 Bypass Road near Spring field school	N33° 58.544' E73° 46.931' Alt. 3536'	Nil	Nil	Nil	7.2	<5	168	Unfit For Drinking
9	Channel to spring 8 Source for Tap stand close to Mercy Corps office	N33° 58.561' E73° 46.933' Alt. 3534'	Nil	Nil	Nil	7.2	<5	<i>Uncountable</i>	Unfit For Drinking
10	Spring 9 Bypass Road near Mosque	N33° 58.479 E73° 46.920 Alt. 3534	Nil	Nil	Nil	7.4	<5	6	Unfit For Drinking
11	Spring 10A By pass near Shell Pump	N33° 58.405' E73° 47.029' Alt. 3544'	Nil	Nil	Nil	7.4	<5	45	Unfit For Drinking
12	Spring 10B By pass near Shell Pump	N33 58.406' E73 47.025' Alt. 3544'	Nil	Nil	Nil	7.4	<5	40	Unfit For Drinking
13	Spring 11 near NRSP office	N33° 58.647' E73° 46.112' Alt. 3442'	Nil	Nil	Nil	7.4	<5	40	Unfit For Drinking
14	Spring 12 Near Former Muslims hands camp	N33° 58.253' E73°47.333' Alt.3637'	Nil	Nil	Nil	7.2	<5	0	Fit For Drinking
15	Spring 13 near Former Muslims hands camp	N33° 58.300' E73°47.299' Alt.3558'	Nil	Nil	Nil	7.6	<5	20	Unfit For Drinking

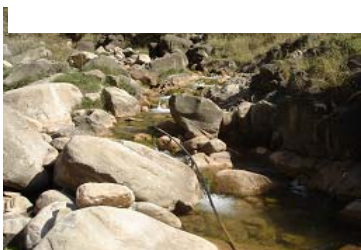
S. No.	Source Type	Location	Color	Odour	Taste	PH	Turbidity (NTU)	Results *	Remarks
23	Spring 15 Near Huda Bari Kashmiri Refugees camp	N33° 59.052' E73° 47.812' Alt. 3994'	Nil	Nil	Nil	7.4	<5	Positive	Unfit for drinking purposes
24	Stream 16 Near Huda Bari Kashmiri Refugees camp	N33° 59.052' E73° 47.782' Alt. 3989'	Nil	Nil	Nil	7.6	<5	Positive	Unfit for drinking purposes
25	Stream 17 Near Huda Bari Kashmiri Refugees camp	N33° 58.938' E73° 47.698' Alt. 3939'	Nil	Nil	Nil	7.4	<5	Positive	Unfit for drinking purposes
26	Spring 18 Near Huda Bari Kashmiri Refugees camp	N33°59.054', E73°47.827', Alt.4040'	Nil	Nil	Nil	7.4	<5	Positive	Unfit for drinking purposes
27	Spring 19 Near Huda Bari Kashmiri Refugees camp	N33°58.844', E73°47.605', Alt.3903'	Nil	Nil	Nil	7.6	<5	Positive	Unfit for drinking purposes
28	Spring 20 YaqoobAbad	N33° 58.638' E73° 45.977' Alt. 3427'	Nil	Nil	Nil	7.2	<5	Positive	Unfit for drinking purposes

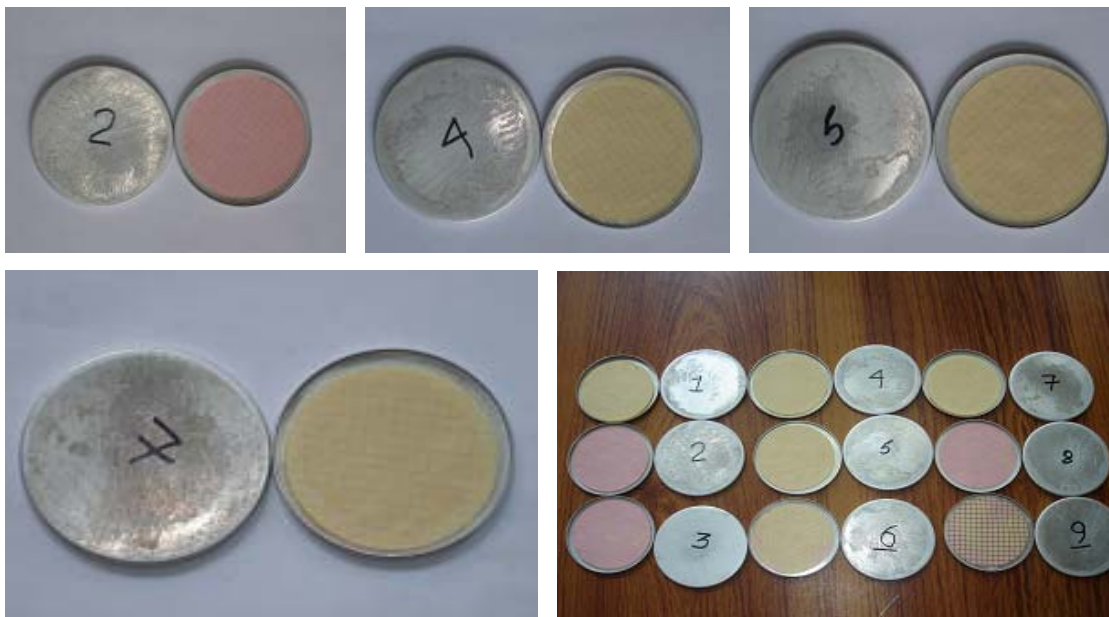
Water sample test results from different water sources of Bagh town

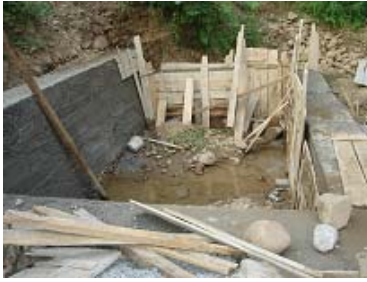
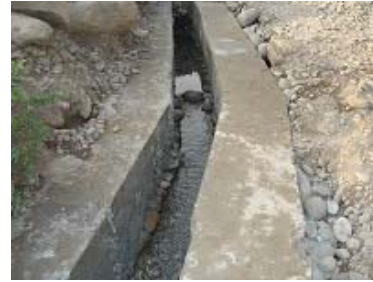
Two main water sources under construction by PHED

- Protection of two major water sources by PHED is in progress.
- OXFAM provided one (T-70) water tank to PHED, due to which chlorinated water will be available to two more areas.
